Sujet : joint de la valve à essence des moteurs hors-bord **PARSUN 5hp**

Object : **PARSUN 5 hp** outboard motors gas valve seal

PRODUITS : MOTEURS HORS-BORD PARSUN 5hp

PRODUCTS : PARSUN 5hp OUTBOARD MOTORS

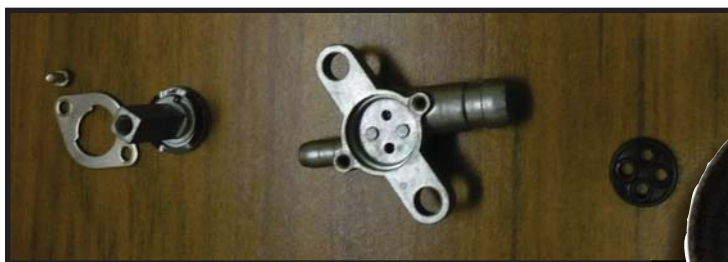
Nous avons remarqué que le joint de la valve à essence se déformait et réduisait le passage de l'essence à travers celui-ci. Nous avons mentionné ce problème à la compagnie Parsun. Depuis mars 2009, le matériel de ce joint a été changé et il est maintenant résistant au mélange éthanol et essence E15 (15% d'éthanol et 85% d'essence).

We noticed that the seal of the gas valve is deformed and reduced gasoline flow. We mentioned this problem to Parsun Company. Since March 2009, the material of this seal has been changed and is now resistant to ethanol and gasoline blend E15 (15% ethanol and 85% gasoline).

trous déformés
deformed hole

Si l'un de vos clients remarque que son moteur Parsun 5 hp (modèle antérieur à 2009) s'arrête après quelques minutes de fonctionnement, vérifiez cette valve. Il est possible que ce soit le problème p/n PAPF4-05000100.

If one of your customers notice that his Parsun 5 hp motor (model prior to 2009) stops working after a few minutes, check this valve. It could be the p/n PAPF4-05000100 problem.
